Manhole Inspection Summary

Manhole # S55C__013MH

Insp Date: **6/23/08 12:07 PM**

Location Address: **3800 e baltimore**

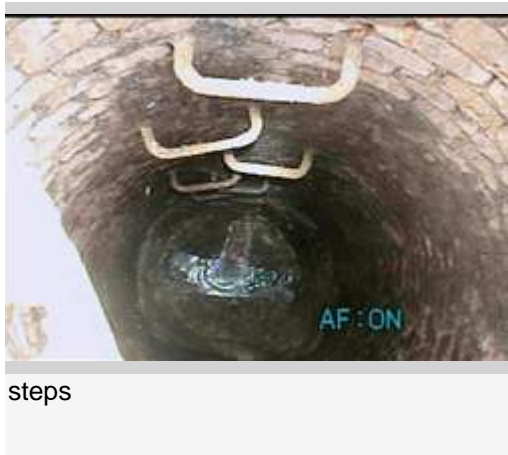
Defect 3

Count: **11** Missing: **0** ☒ **Corroded**

steps

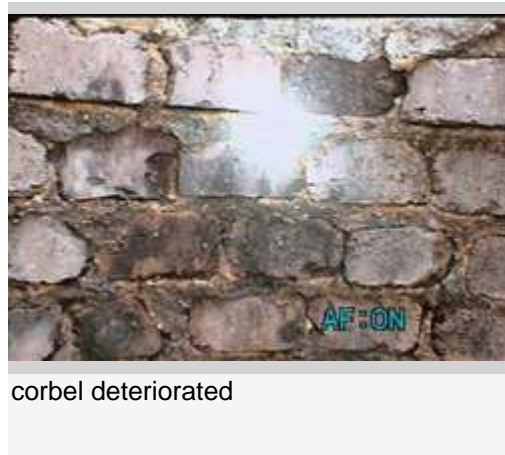
Defect 2

Condition: ☐ Sound ☐ Cracked ☐ Root Intrusion ☐ Loose Brick ☒ **Deteriorated**

corbel deteriorated

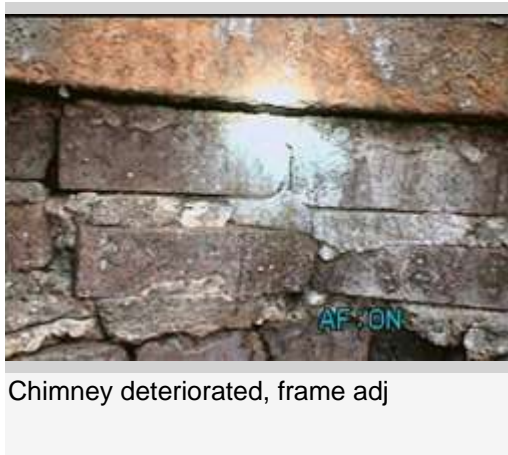
Defect 1

Condition: ☐ Sound ☐ Cracked ☐ Root Intrusion ☐ Loose Brick ☒ **Deteriorated**

Chimney deteriorated, frame adj

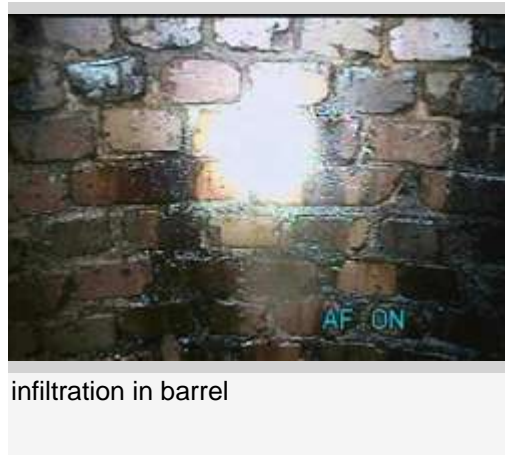
Defect 5

Infiltration: ☐ None ☐ Joint ☐ Cracks ☐ Mortar ☐ Roots ☒ **Wall**

infiltration in barrel

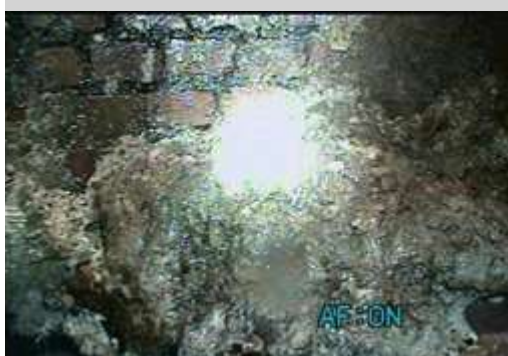
Defect 4

Condition: ☐ Sound ☐ Cracked ☐ Root Intrusion ☐ Deteriorated ☐ Leaks ☒ **Debris**

bench debris

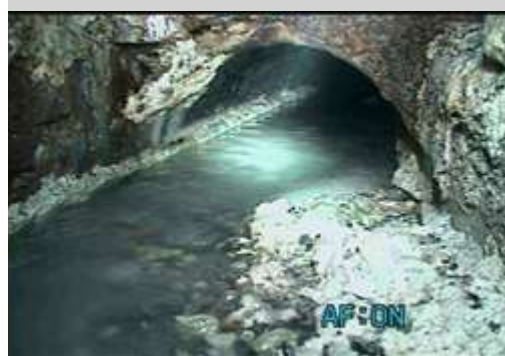
Defect 6

Condition: ☐ Sound ☐ Cracked ☐ Root Intrusion ☐ Deteriorated ☐ Leaks ☒ **Debris**

Channel Debris
